# QUINQUENNIAL INSPECTION & REPORT

## St Mark's Church, Harrogate

Diocese of Leeds & Archdeaconry of Richmond and Craven

September 2025

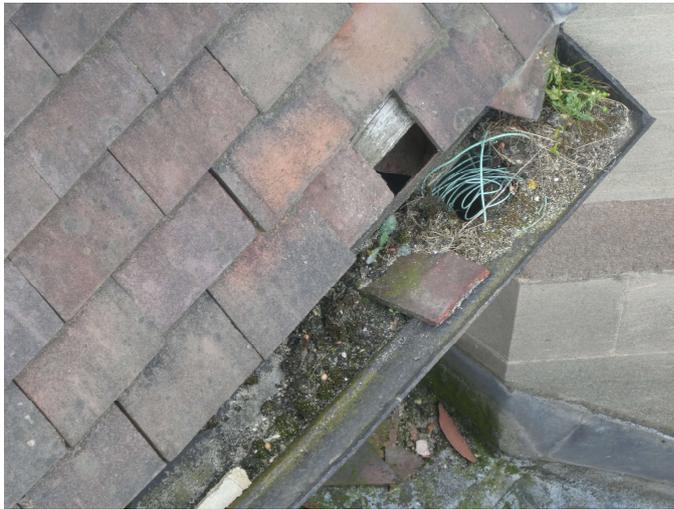
There is a serious defect where the west side of the organ loft joins the north side of the chancel roof. A tile is missing, the gutter damaged and debris blocking the lead valley below. As shown in the following photograph.

It is essential that all roof repairs noted above are undertaken within a twelve month period.

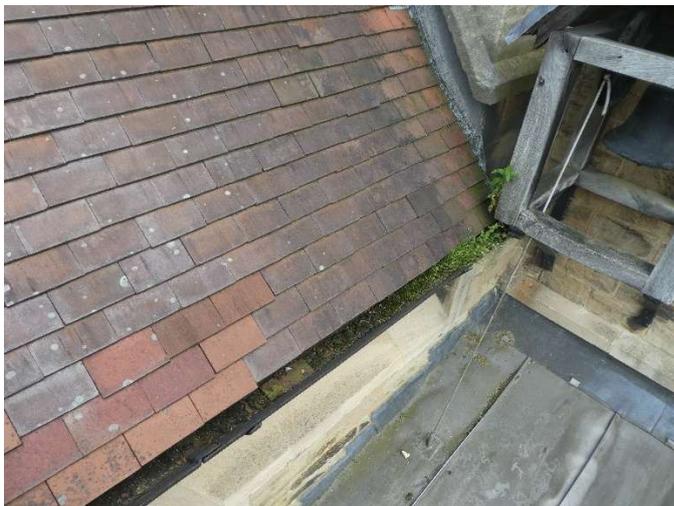
The gutter on the north side is blocked against the main building by vegetation, adjacent to the bell.

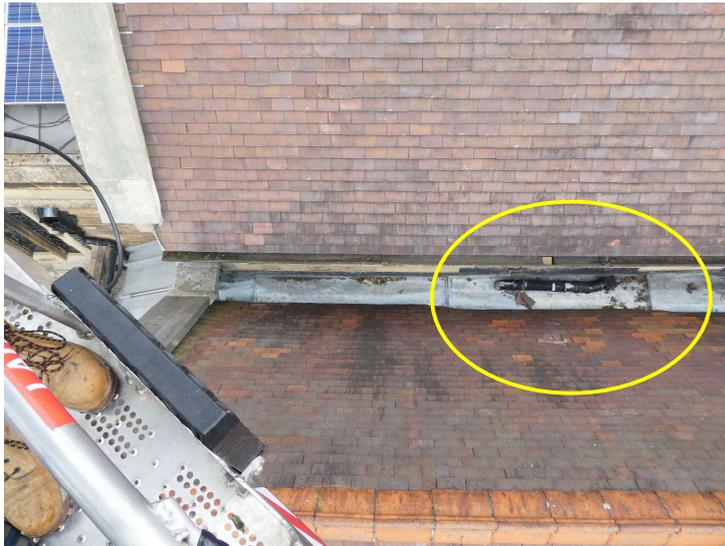
The upper roof is served by a cast iron gutter. The rainwater pipe from this gutter, just above the lead lined valley gutter between roofs, has fallen away and landed on the lead. In falling, the pipe has broken tiles on the adjacent roof. The damage needs repairing and the rainwater pipe needs replacing with a more suitable pipe. The lead valley gutter should be checked when accessible.

Rainwater pipe shown in gutter

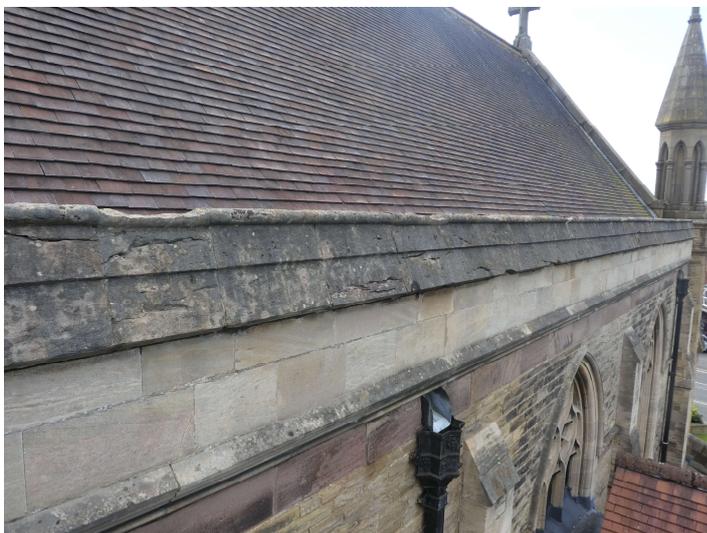
Broken and fractured coping stones

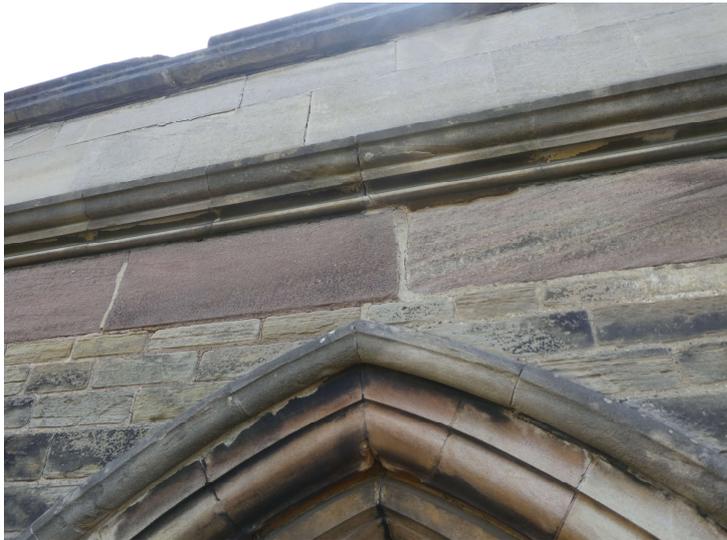
Open joints in parapet walling

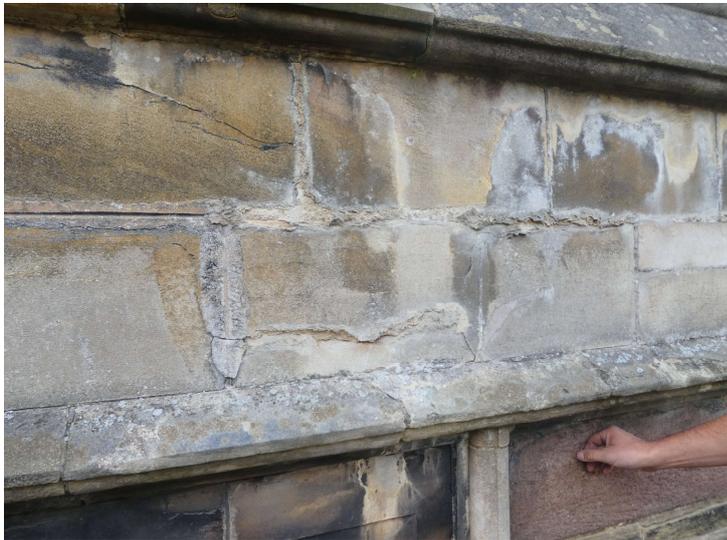
Defective walling and pointing

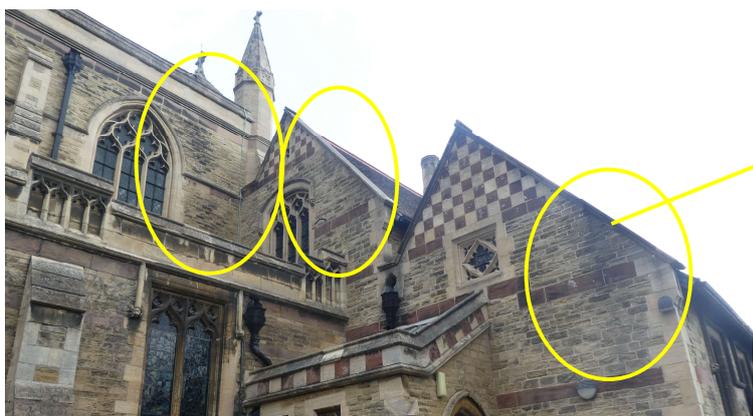
South east elevation

Water ingress from defective joint in copings

All open joints should be pointed up as a matter of some urgency to prevent further deterioration.

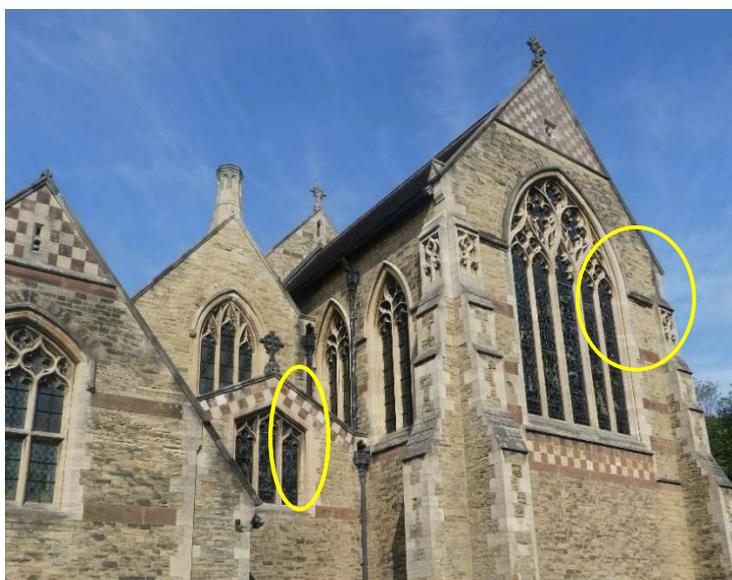
East elevation – upstand walls and

copings

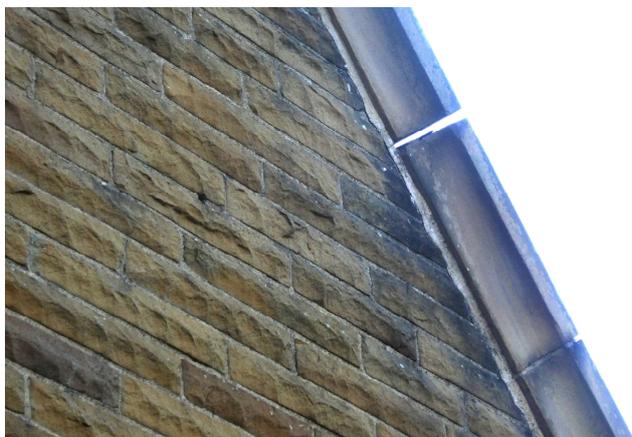
West elevation, open joints

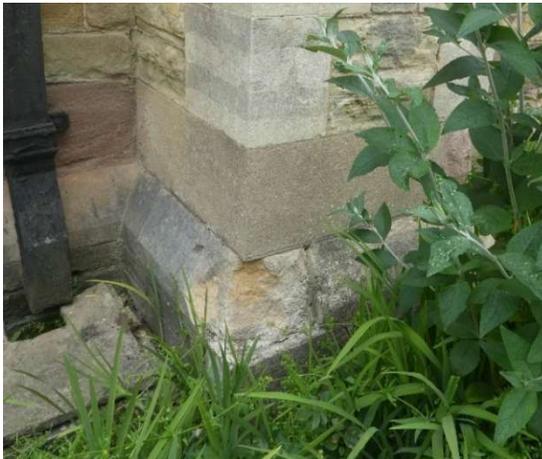
Plinth courses have eroded and/or fractured in many locations. This has been the result of moisture penetrating the relatively soft stone and aggravated in places by the build up of vegetation around the church. Much of the vegetation has been cut back recently, allowing the walls to dry naturally. Other failures result from the red sandstone course above the plinth eroding, leaving the plinth below vulnerable.

Fracture of damp plinth (south elevation)

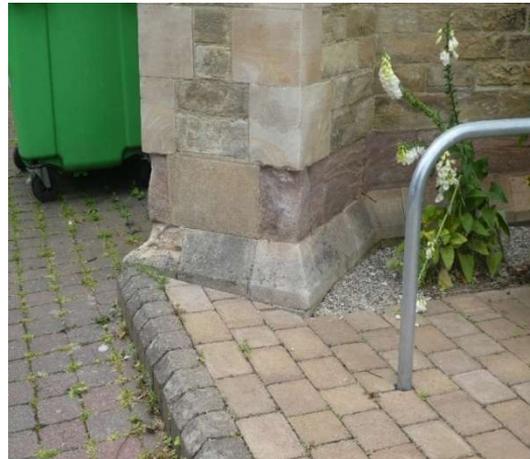
Erosion of red band and plinth

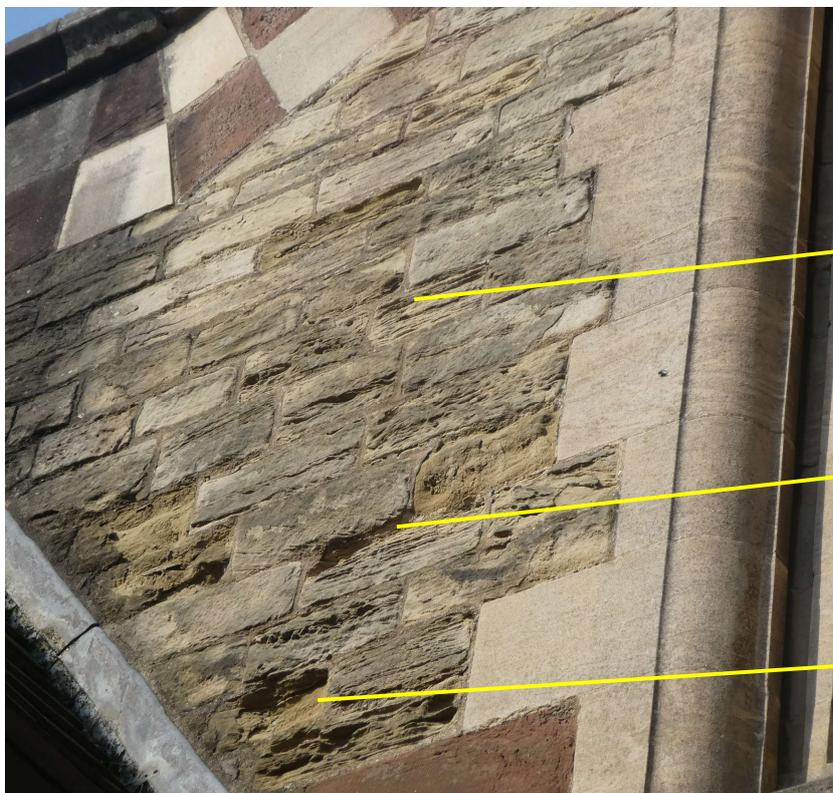
Wall to south side of chancel.

Sedimentary nature of masonry, showing erosion

General erosion

Wind erosion

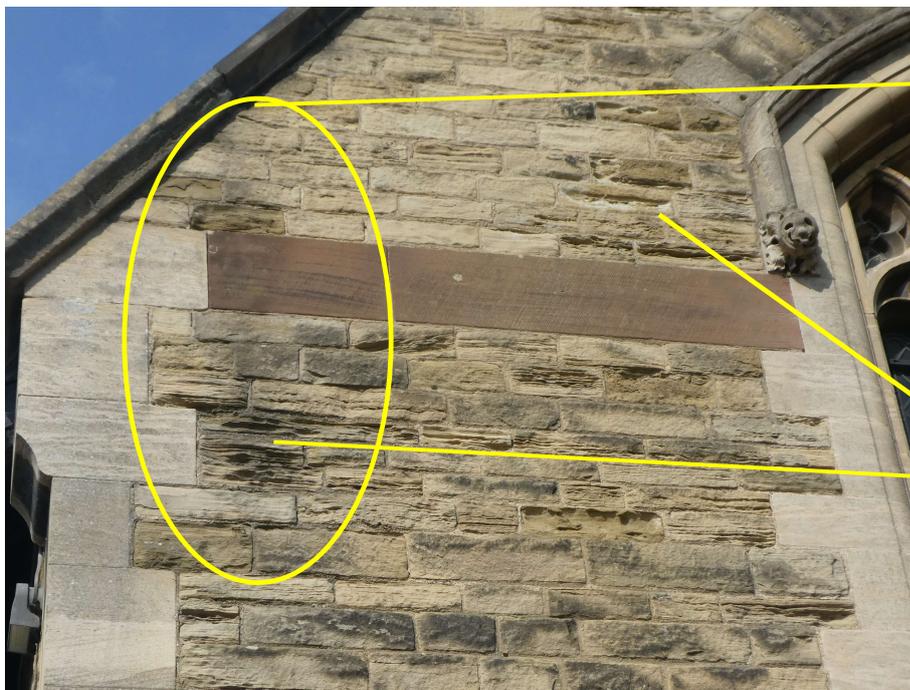
Gap in coping allowing water to run down wall

Water staining and erosion

The effect of this erosion is to allow moisture to penetrate into the external walls. This has occurred above the south choir door where internal plaster is defective as a result of water

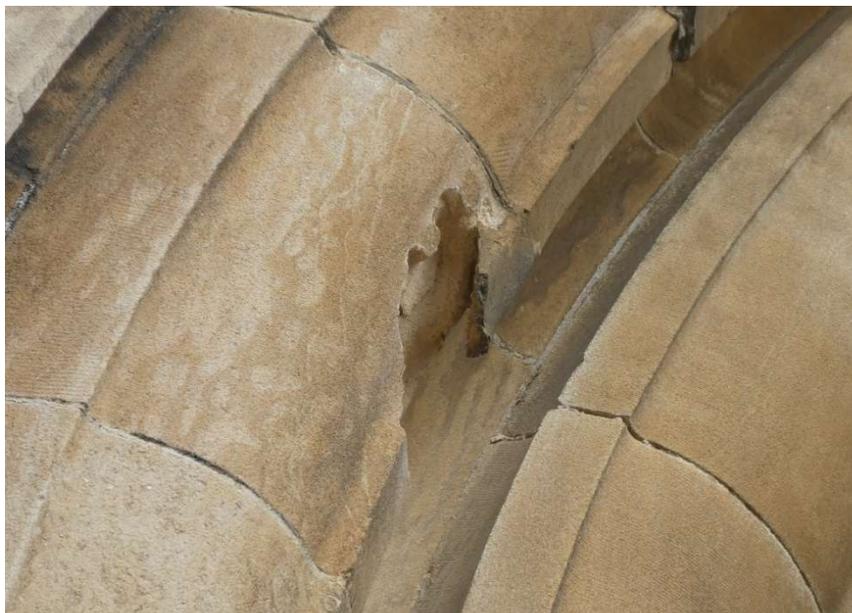
South porch

Ashlar stonework is generally in excellent condition. There are a very few locations where wind driven erosion has occurred. In these places, the defective stone should be cut out and replaced, as in the following example.

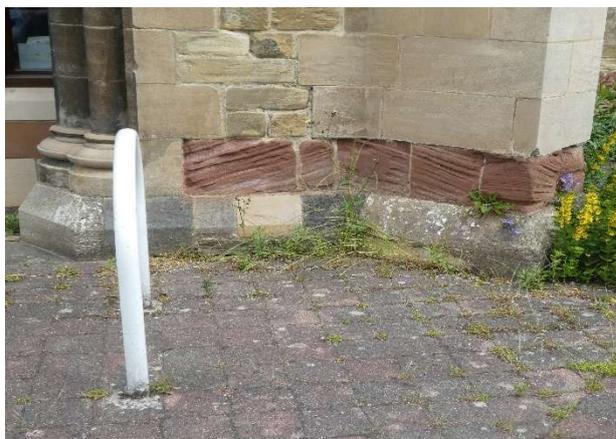
East side of old porch

The main defects are to the south and west elevations, around the base of the porch and nearby buttresses as shown below:

Wherever there are defective blocks, they should be repaired. The extent and type of repairs needs further consideration but in many cases it should be possible to cut up to 100mm from the face of the block and replace with new stonework held in position with stainless steel rods glued into position.

It is likely approx. 20 such stone blocks will need to be replaced within the next 2 years.

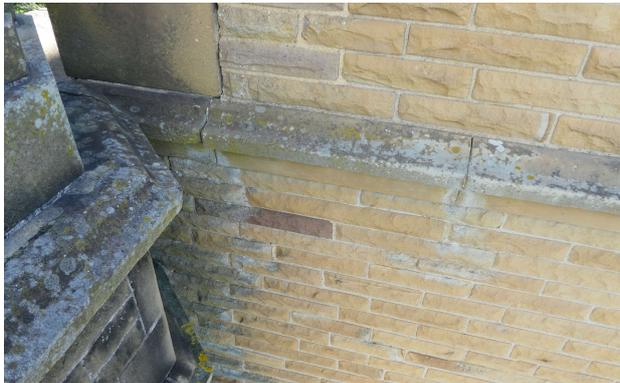
There is considerable water penetration into the walling of the main gable, west elevation, particularly where joints in contrasting bands have opened up and are allowing water penetration.

Open joints and staining. West elevation

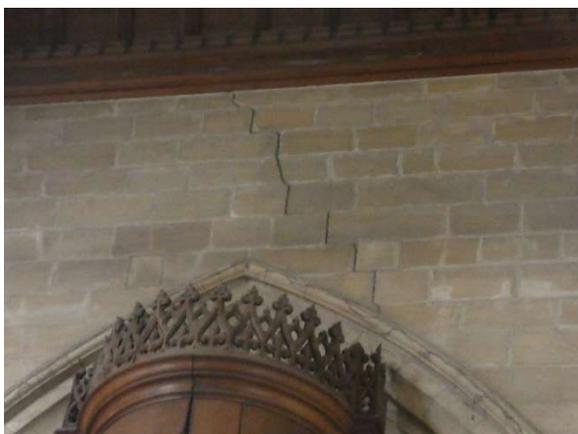
Movement cracking above the organ was noticed 18 months ago and should be monitored. There is no reciprocal cracking externally. There are a number of vertical cracks to the curved masonry adjacent to the organ loft.

Open joints above organ and behind staircase

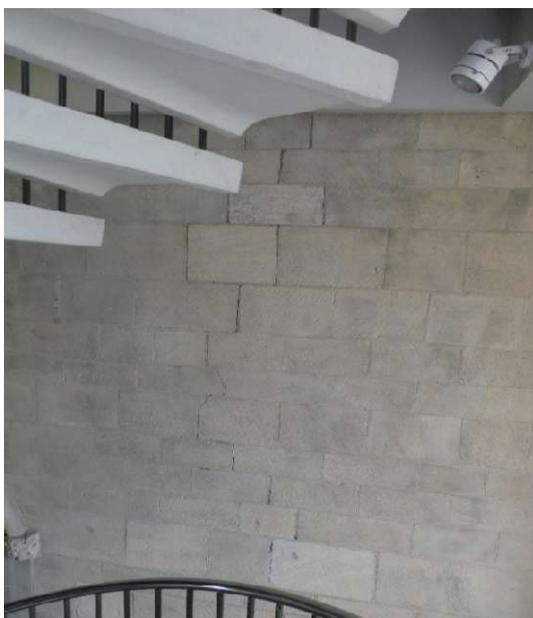
Vertical cracking is evident behind the spiral staircase. This is not evident externally although there is cracking through window surrounds nearby. All cracking should be monitored.

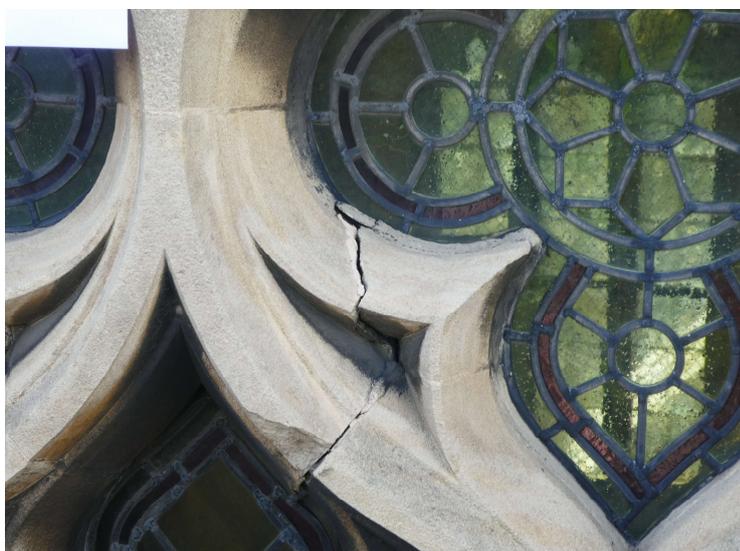
Movement through tracery

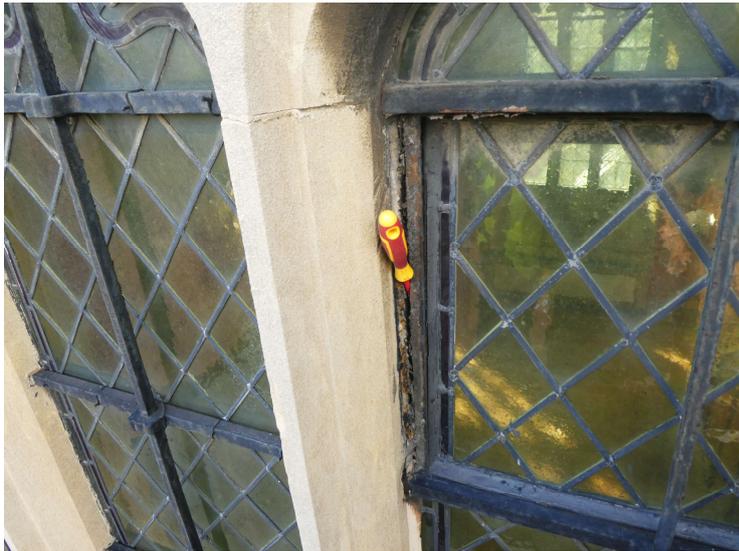
Missing putties & pointing

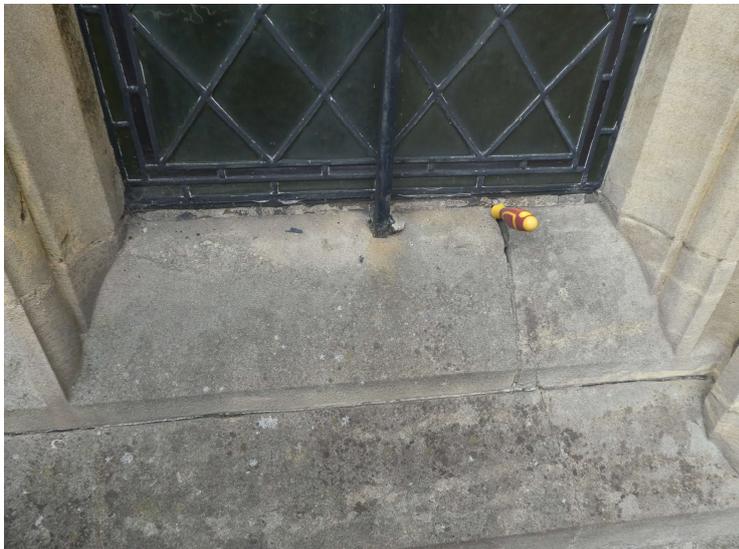
Open joints in cills

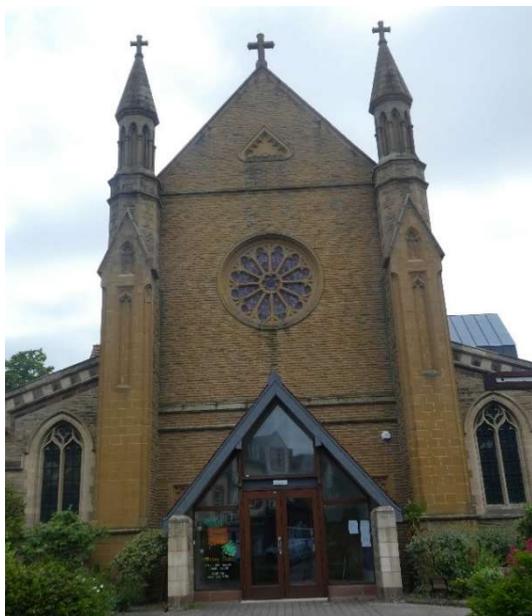
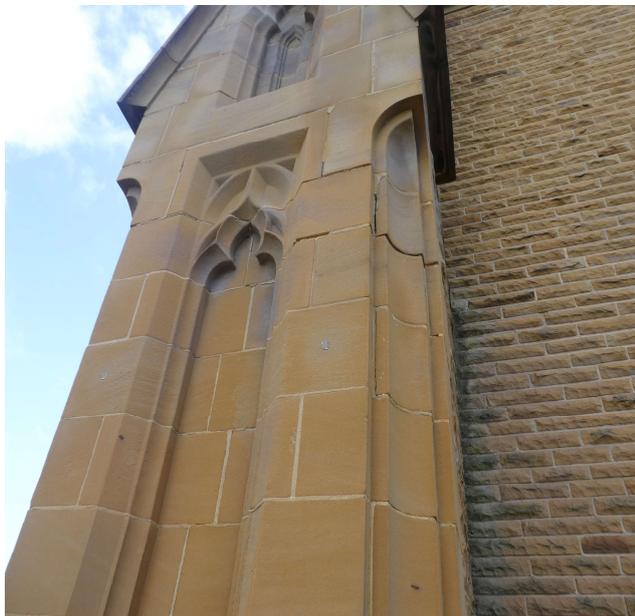
West elevation & North west buttress

There are open joints to both west end pinnacles and buttresses which need to be repaired to prevent moisture entering the structure.

The faults need further investigation to ensure structural stability and to check whether any ferrous ironwork within the walling is affected by moisture.

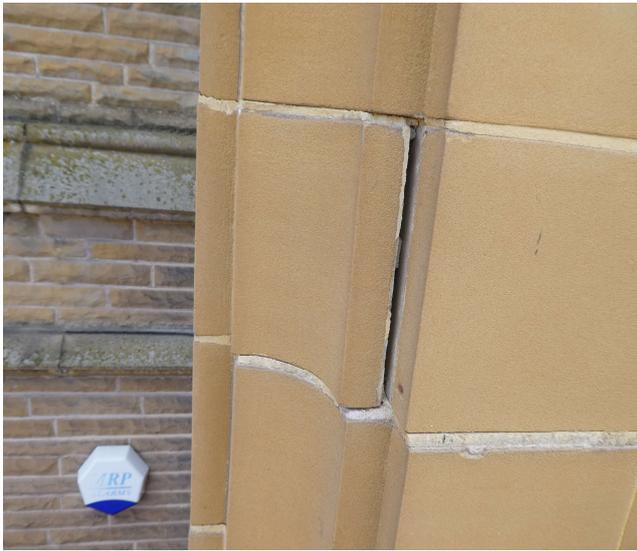
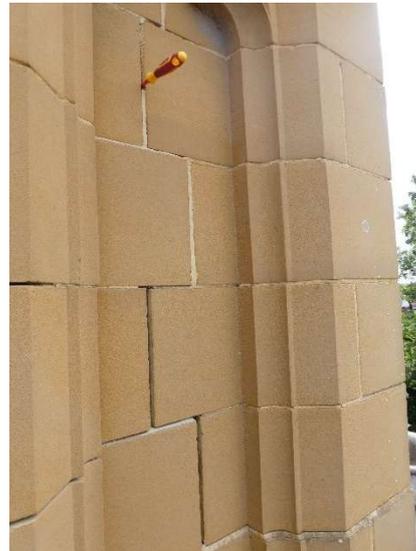
South west buttress

Examples of movement and open joints to the south west buttress are shown in the following photographs.

The stone block shown a little above the intruder alarm light was protruding approx. 25mm at the start of the inspection but was pushed back into position.

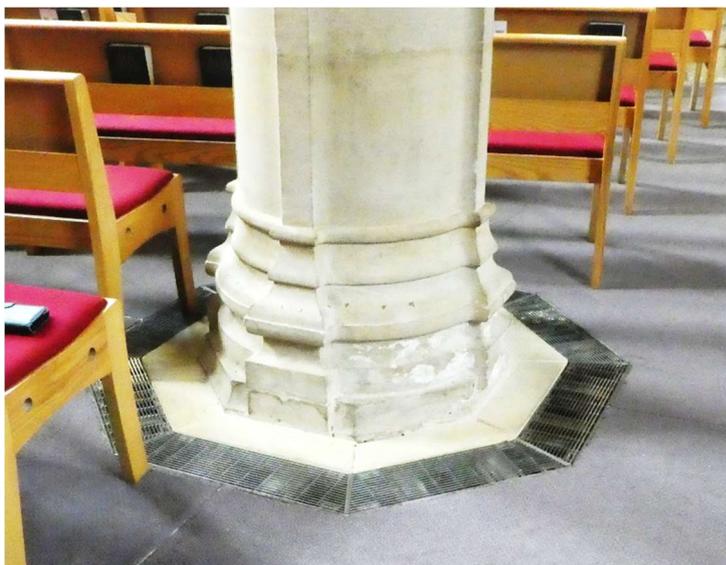
A historic issue between a column and floor to the right of the font seems to have been corrected. It is understood that there were stress issues possibly caused by installation of a solid floor and underfloor heating. There were some problems with rising damp, possibly related to the new concrete floors drying out. No problems are obvious now although some efflorescence is visible suggesting drying out continues. As can be seen in the photograph below, vents have been incorporated to encourage drying out and to prevent any further expansion damage.

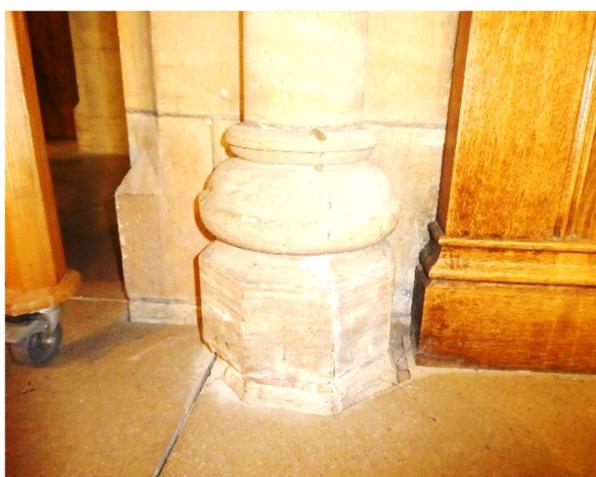
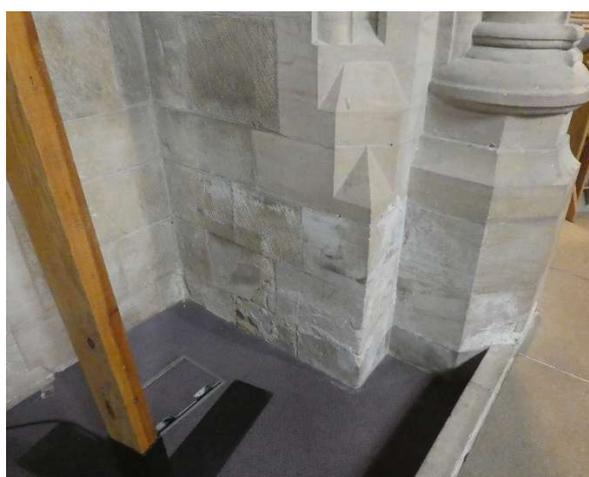
Adjacent organ

There is stress cracking at the base of columns adjacent the organ loft which should be monitored.

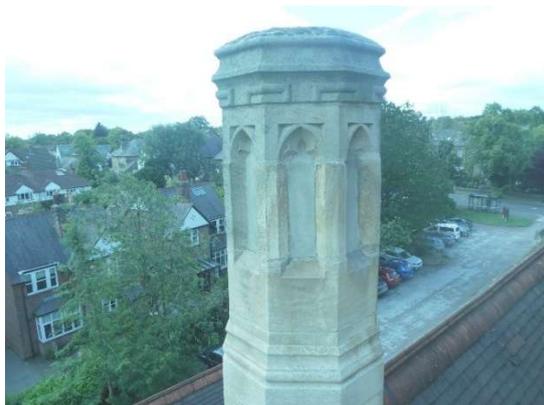
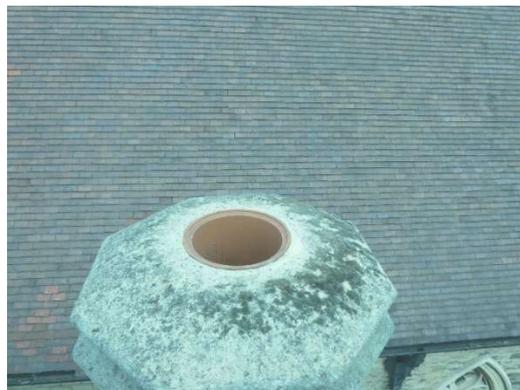
The boilers discharge to a single flue outlet which exits from a stainless steel lined chimney stack. Original vertical vents have been filled in with sand and cement mortar. There is erosion to the stonework. There is no cap to the flue to prevent water ingress. Advice should be taken on whether a cap would be beneficial.

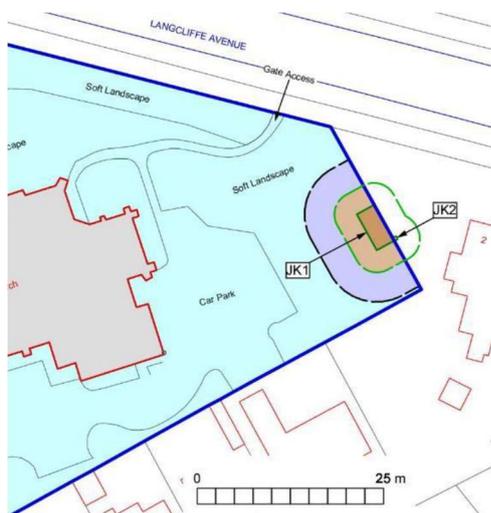
There is an area of Japanese Knotweed close to the north east boundary, shown in the plan below. This area is fenced off and undergoing treatment. Documentation is appended, **Appendix N**

Area of contaminated ground

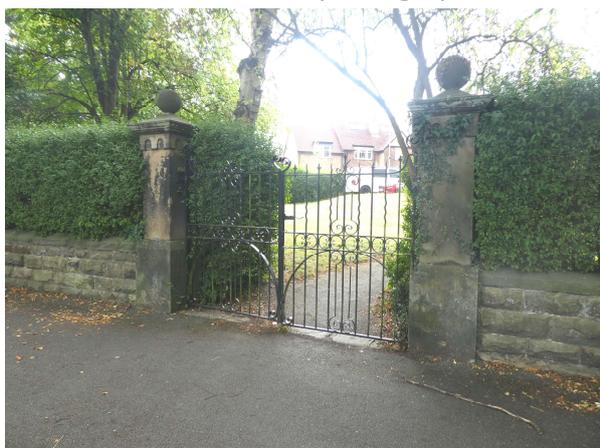
Ivy is growing up the gate piers and should be removed. Hedging is overgrown to one side and should be cut back. See photograph.

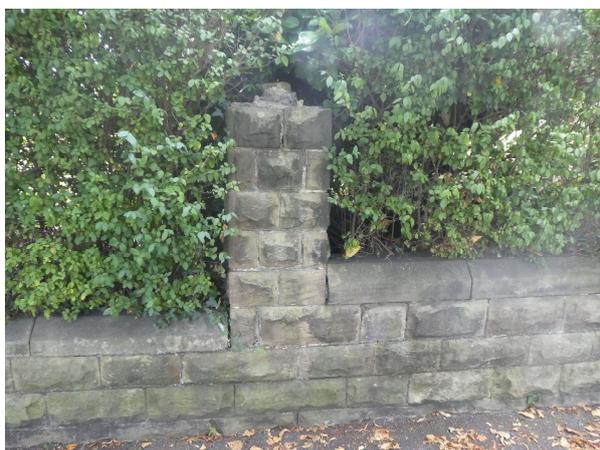
There are intermediate stone posts, capped with ornamental balls. One is missing and the top of the pier is disintegrating and should be rebuilt.
